CLIENT: **Amco Construction**
 SERVICE: **Amex[®]-10-Seal**
 PROJECT: **Joint repair to 900mm pipeline on gradients of upto 50%**

INTERNAL AMEX-10-SEAL REPAIR OF HYDROELECTRIC PIPELINE BY PMP

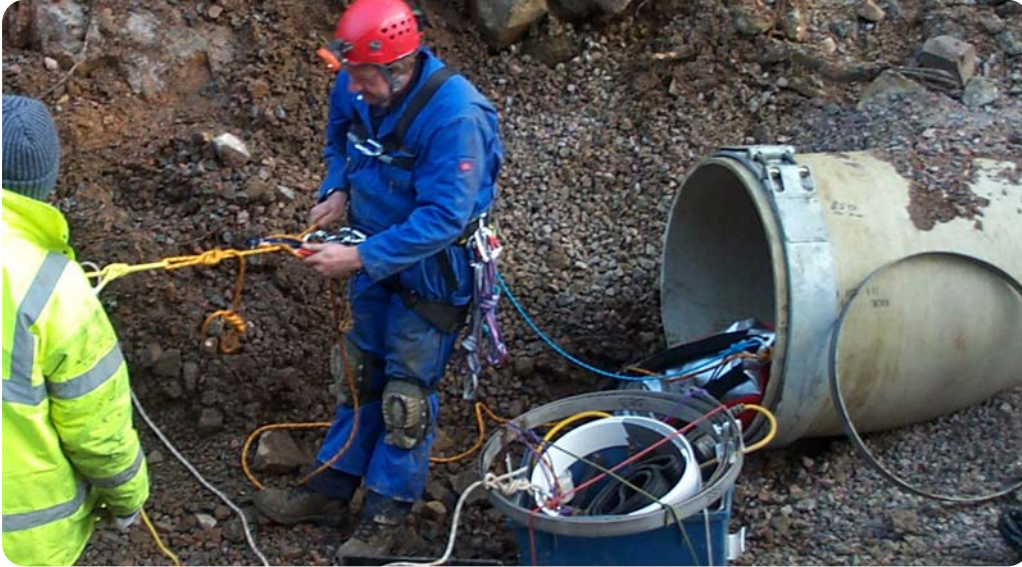
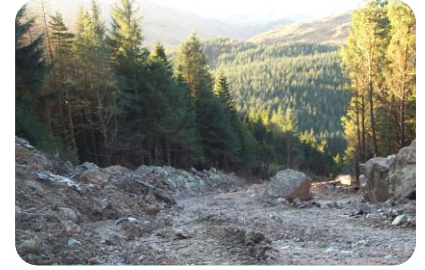
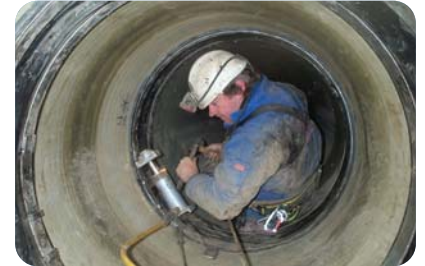
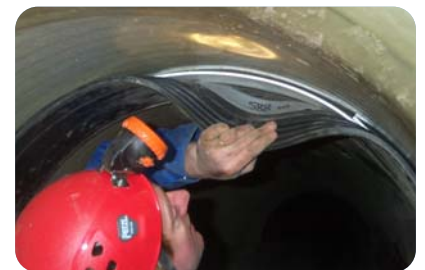
AMCO Construction contacted PMP for a solution to the out-of-tolerance joints. PMP proposed using the Amex-10-Seal, which is a low profile mechanical seal for internal repair of leaking pipe joints. A robust

section of rubber that spans the joint is fitted using hydraulic expansion of stainless steel compression rings, thus eliminating the use of chemical adhesives and their associated hazards. The seal accommodates substantial joint movement and is abrasion resistant. Each seal has an independently verified life expectancy of more than 50 years.

PMP engineers used roped access skills to fit the unique Amex-10-Seals from within the pipe. By completing all repairs internally, trenching and service costs were avoided. The Kingairloch scheme presented PMP with difficult working conditions. PMP's Stephen Taylor explained that roped access was required to reach down to pipe joints where the operating pressure approached 25 bar. Working from a removed section of the 900mm pipe, the PMP engineer was lowered to the location of each leaking joint, in order to carry out the preparation and fitting of the seals. In total 28 seals were fitted over a period of 2-3 months.
